Manhole Inspection Summary

Manhole # S19I1_033MH

Insp Date: **4/18/08 9:35 AM**

Location Address: **3025 lorena av**

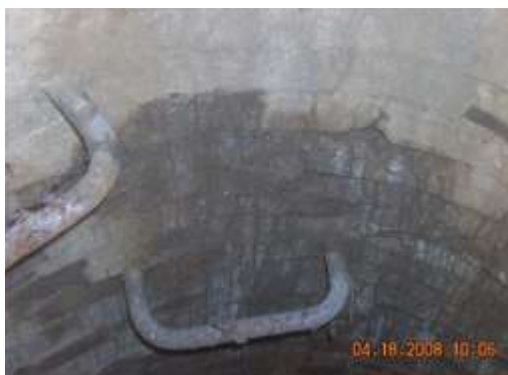
Defect 3

Condition: ☐ Sound ☒ **Cracked** ☐ Root Intrusion ☐ Loose Brick ☐ Deteriorated

Infiltration: ☐ None ☒ **Joint** ☒ **Cracks** ☐ Mortar ☐ Roots ☐ Wall

corbel cracked, infiltration @ corbel cracks

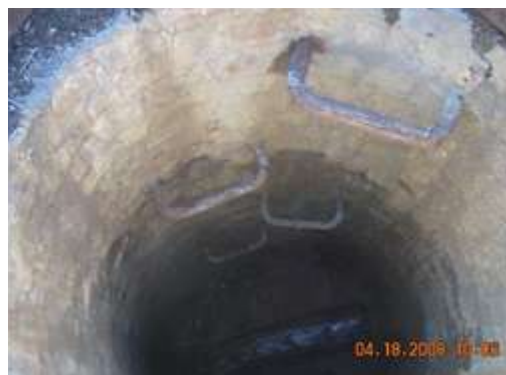
Defect 2

Steps Count: **5** Missing: **0** ☒ **Corroded**

corroded steps, infiltration @ corbel/chimney joint

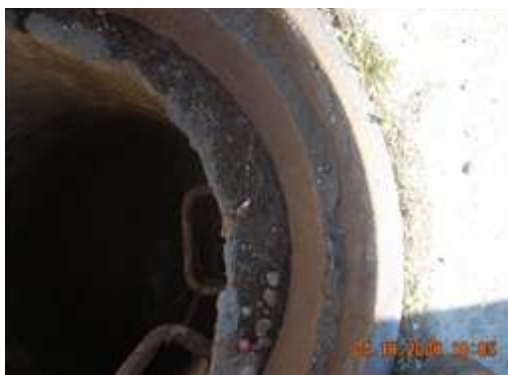
Defect 1

Frame Offset: **2** (in.) Condition: ☒ Sound ☐ Cracked ☐ Leaks

frame offset

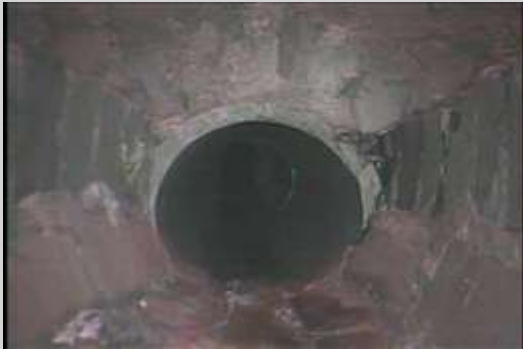
12 O'Clock Outflow

Pipe Height: **8.4** (in.) Rod and Bar (Angled)
Pipe Material: **Clay** ☐ Pipe Lined
Invert Depth: **9.71** (ft.) Flow Characteristics: **Slow**
Deposits: ☒ None ☐ Mud ☐ Sludge ☐ Debris ☐ Grease
Silt Depth: **0** (in.) Deposits Extent:
Infiltration: **None** Pipe Seal Cond: **Sound**

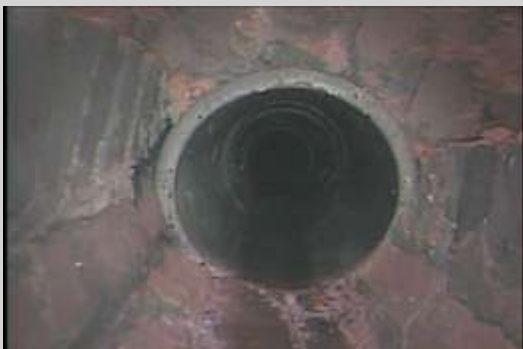
7 O'Clock Inflow

Pipe Height: **8.4** (in.) Rod and Bar (Angled)
Pipe Material: **Clay** ☐ Pipe Lined
Invert Depth: **9.35** (ft.) Flow Characteristics: **Slow**
Deposits: ☒ None ☐ Mud ☐ Sludge ☐ Debris ☐ Grease
Silt Depth: **0** (in.) Deposits Extent:
Infiltration: **None** Pipe Seal Cond: **Sound**
